**Flood Control Project Maintenance
Levee Inspections****LMA District Cover Sheet****Spring 2013 Levee Inspection Results****Sacramento Maintenance Yard Willow Slough Bypass**

Levee Inspection Report By Mile - Spring 2013

Sacramento Maintenance Yard Willow Slough Bypass

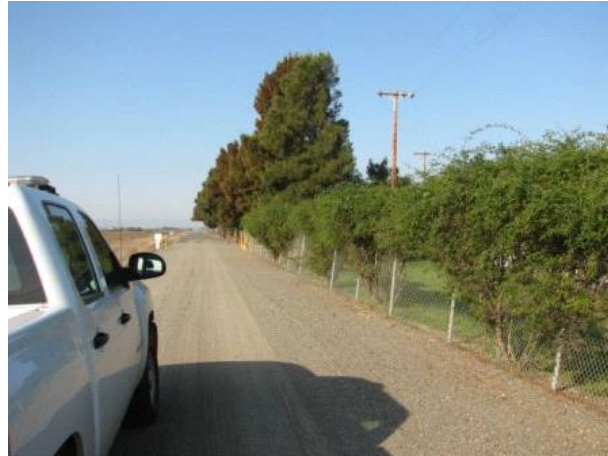
Levee Mile Report Line	4
Start Levee Mile	0.02
End Levee Mile	0.15
Location	Crown
Category	
Item	Vegetation

The treatment plant's landscape and fence. This runs along the crown and toe of the levee.

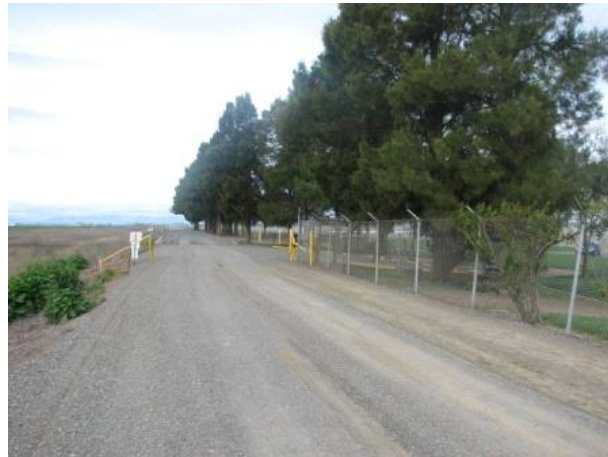
Levee Mile Report Line	4
Start Levee Mile	0.02
End Levee Mile	0.15
Location	Crown
Category	
Item	Vegetation

Photo taken spring 2012, the treatment plants landscaping.

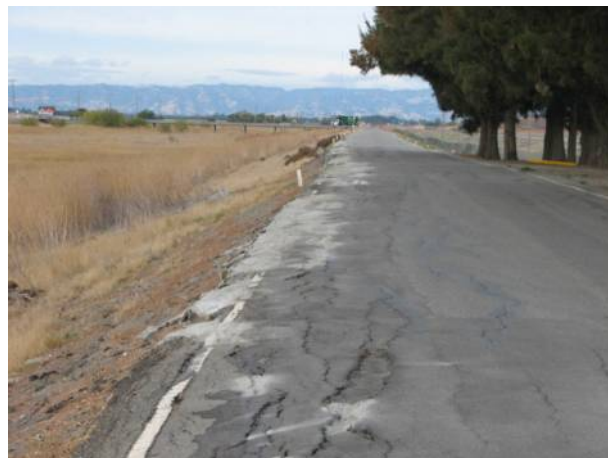
Levee Mile Report Line	5
Start Levee Mile	0.07
End Levee Mile	0.21
Location	Water Side
Category	
Item	Cracking

There is still cracking sloughing on the waterside crown. Attempts to fill in the cracks all along the roadway have been done.

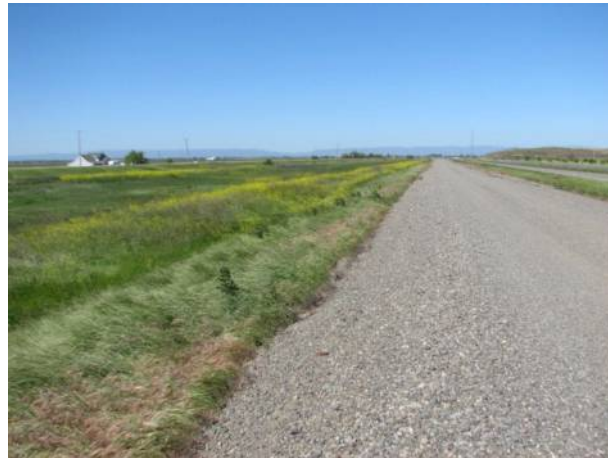
Levee Mile Report Line	7
Start Levee Mile	0.67
End Levee Mile	5.06
Location	Water Side
Category	
Item	Vegetation
The grasses are taller than 12". Spring 2013	
johngw_s_20130422_961.JPG

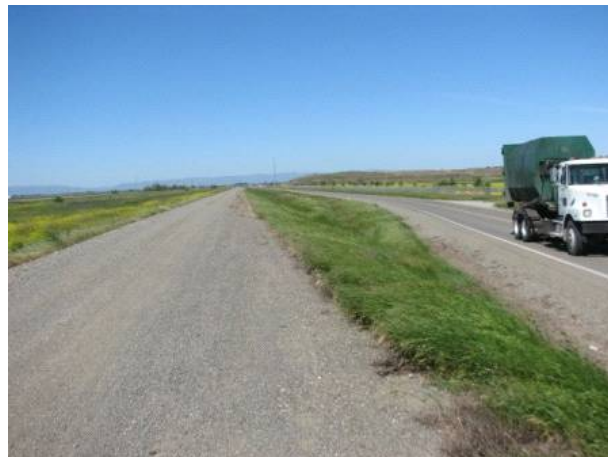
Levee Mile Report Line	8
Start Levee Mile	0.67
End Levee Mile	5.06
Location	Land Side
Category	
Item	Vegetation
The grasses are taller than 12". Spring 2013	
johngw_s_20130422_960.JPG

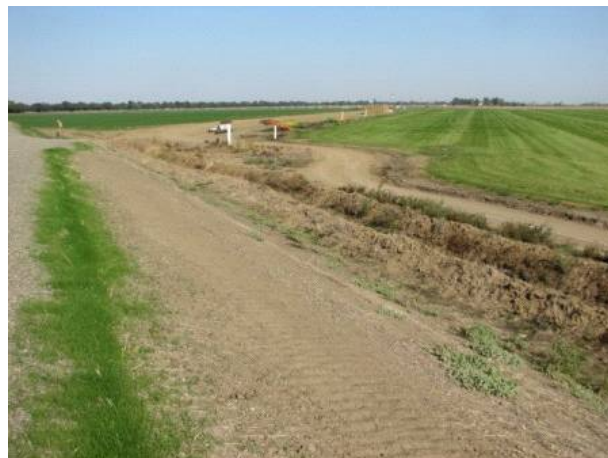
Levee Mile Report Line	9
Start Levee Mile	4.16
End Levee Mile	4.63
Location	Land Side
Category	
Item	Encroachments
The agricultural ditch runs along the toe of the levee. Fall 2011	
johngw_s_20130221_776.jpg

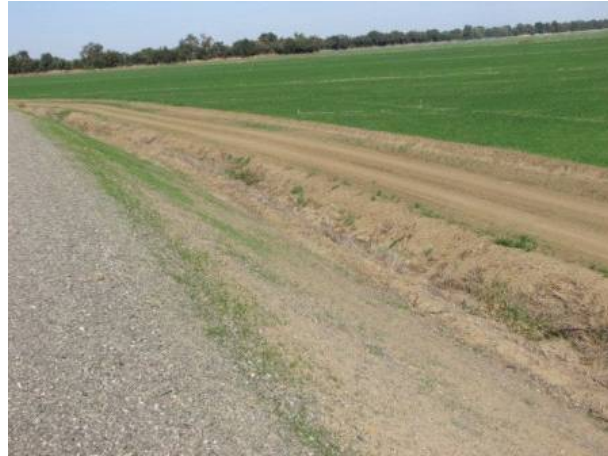
Levee Mile Report Line	9
Start Levee Mile	4.16
End Levee Mile	4.63
Location	Land Side
Category	
Item	Encroachments

Another view of the agricultural running along the toe of the levee. Fall 2011

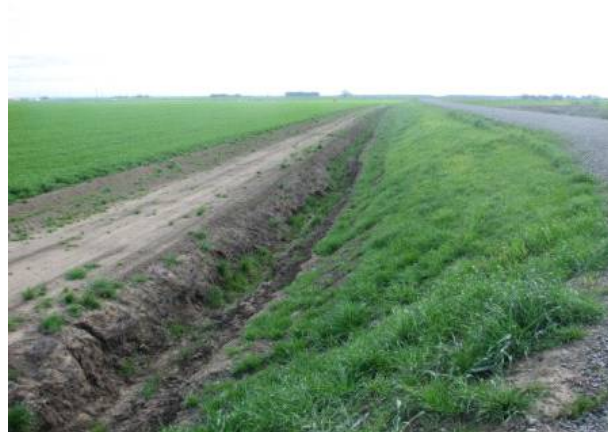
Levee Mile Report Line	9
Start Levee Mile	4.16
End Levee Mile	4.63
Location	Land Side
Category	
Item	Encroachments

Photo taken spring 2012, agricultural ditch along landside toe.

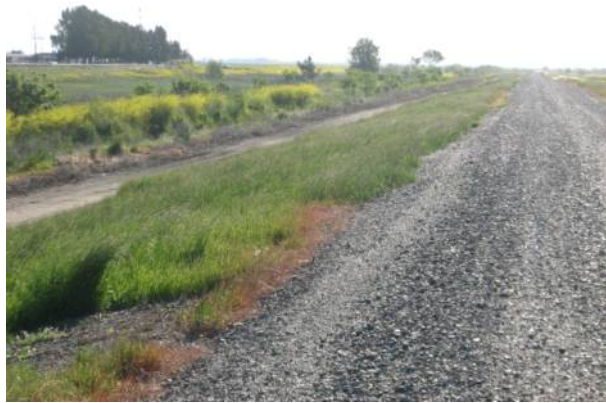
Levee Mile Report Line	1
Start Levee Mile	0.00
End Levee Mile	7.37
Location	Water Side
Category	
Item	Vegetation
The grasses are shorter than 12". Spring 2013	
johngw_s_20130422_963.JPG

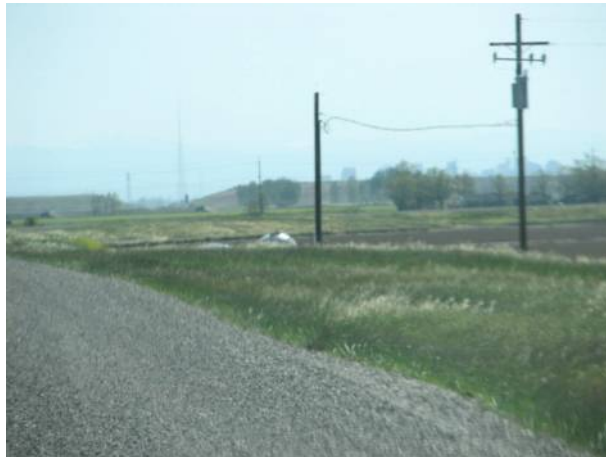
Levee Mile Report Line	2
Start Levee Mile	0.00
End Levee Mile	7.37
Location	Land Side
Category	
Item	Vegetation
The grasses are taller than 12". Spring 2013	
johngw_s_20130422_962.JPG

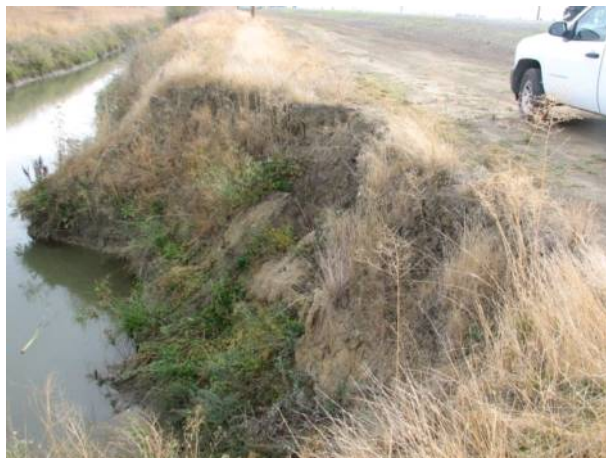
Levee Mile Report Line	3
Start Levee Mile	1.71
End Levee Mile	1.71
Location	Water Side
Category	
Item	Erosion / Bank Caving
Erosion on the edge of the channel. Fall 2012	
johngw_s_20130221_788.jpg

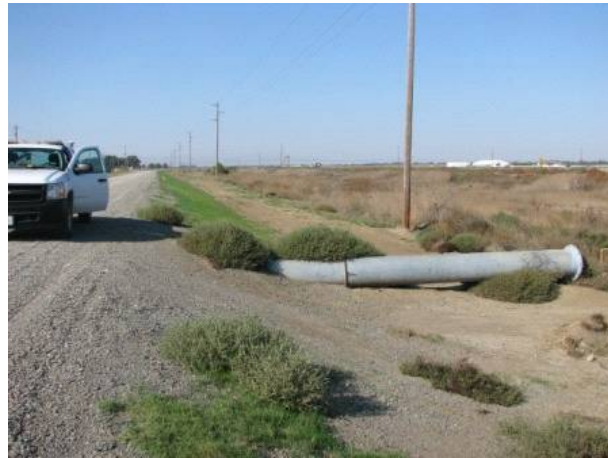
Levee Mile Report Line	4
Start Levee Mile	1.86
End Levee Mile	1.86
Location	Water Side
Category	
Item	Encroachments

A pipe crossing thru the levee and blocking toe road. Fall 2011

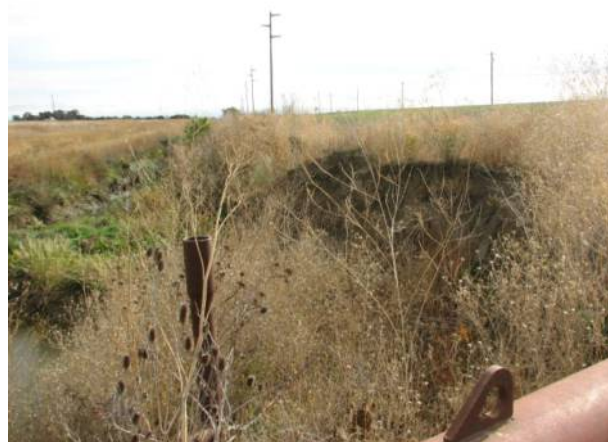
Levee Mile Report Line	5
Start Levee Mile	1.86
End Levee Mile	1.86
Location	Water Side
Category	
Item	Erosion / Bank Caving

Erosion on the edge of the channel. Fall 2012

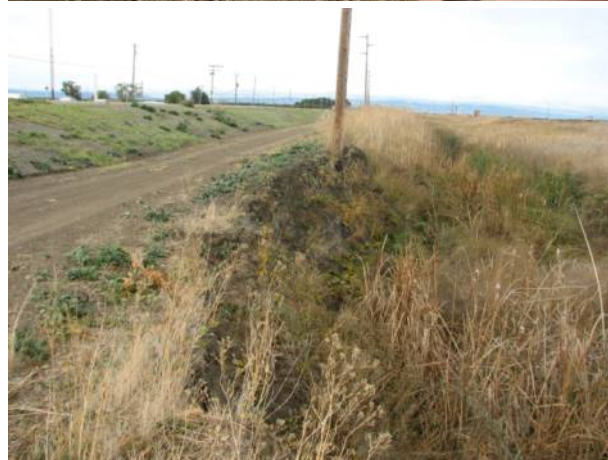
Levee Mile Report Line	6
Start Levee Mile	1.97
End Levee Mile	1.97
Location	Water Side
Category	
Item	Erosion / Bank Caving

Erosion on the edge of the channel. Fall 2012.

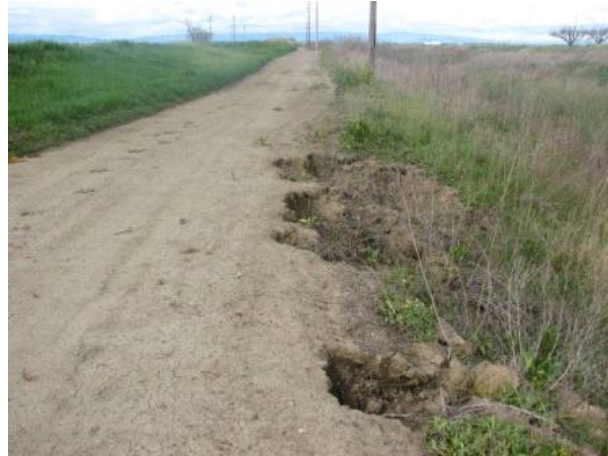
Levee Mile Report Line	7
Start Levee Mile	2.66
End Levee Mile	2.66
Location	Water Side
Category	
Item	Erosion / Bank Caving

Photo taken spring 2012, the erosion encroaches into the toe road.

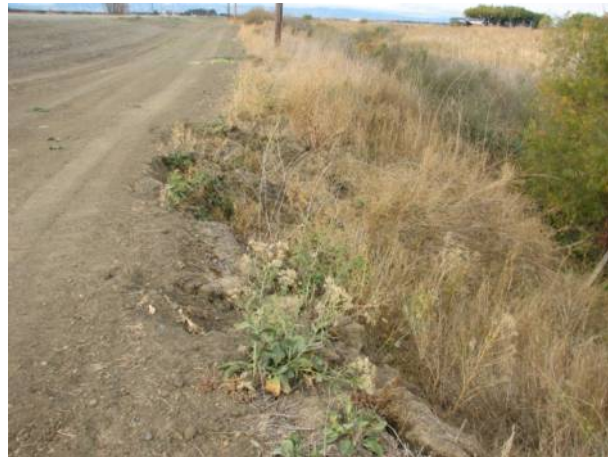
Levee Mile Report Line	7
Start Levee Mile	2.66
End Levee Mile	2.66
Location	Water Side
Category	
Item	Erosion / Bank Caving

Erosion on the edge of the channel. Fall 2012

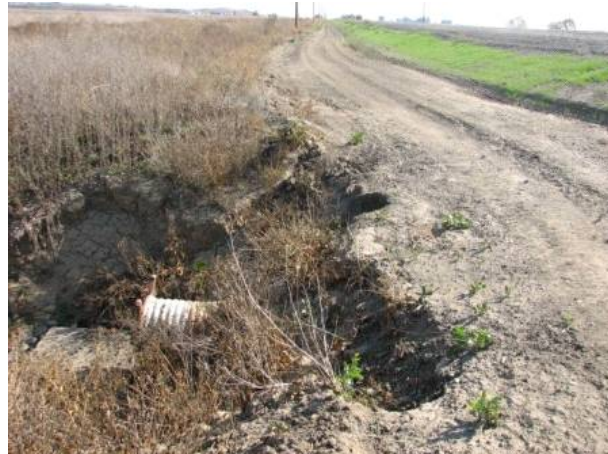
Levee Mile Report Line	8
Start Levee Mile	2.90
End Levee Mile	2.90
Location	Water Side
Category	
Item	Erosion / Bank Caving

The slope around the discharge pipe is eroding the toe road. Rip rap could be placed around the pipe and re-sloped. Fall 2011

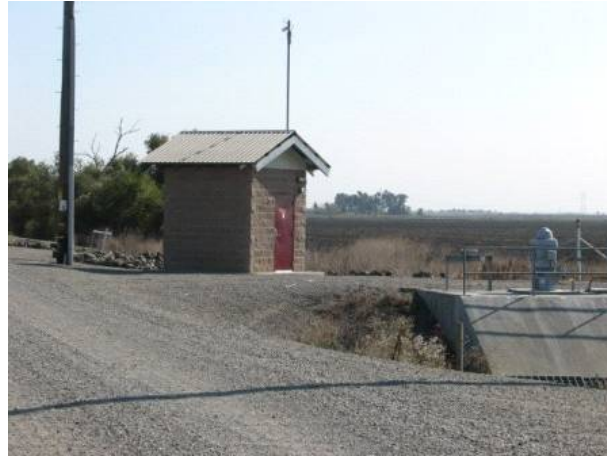
Levee Mile Report Line	9
Start Levee Mile	3.56
End Levee Mile	3.56
Location	Land Side
Category	
Item	Encroachments
A control structure is placed on top of the levee. Fall 2011	
johngw_s_20130221_783.jpg
